## AWWA C900, C905, C909 Hydro Testing

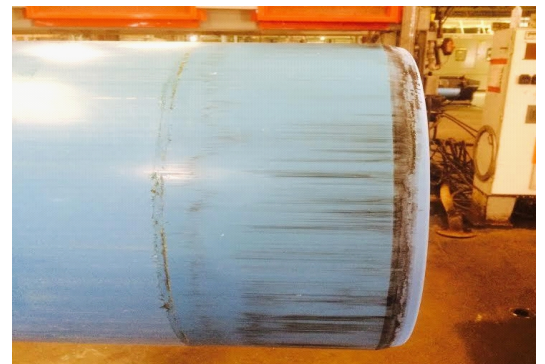
After hydro testing black residual marks may be visible on the spigot end.

Marks are a natural affect in rubber compounds for gaskets. Additives approved for water content; such as, antioxidants, wax, oil, and carbon black, are present in the rubber compound and on gasket surfaces. Such ingredients may rub off during hydro testing and seen on the spigot.

All the ingredients present in the rubber compound are NSF/ CSA listed for drinking water contact. The rubber compound used to manufacture the gaskets is also NSF/ CSA listed as such.

Black residual marks on PVC pipe spigot
